## **East Lansing Public Schools - Elementary Facilities Overview**

06.20.16

## Elementary Facilities Overview:

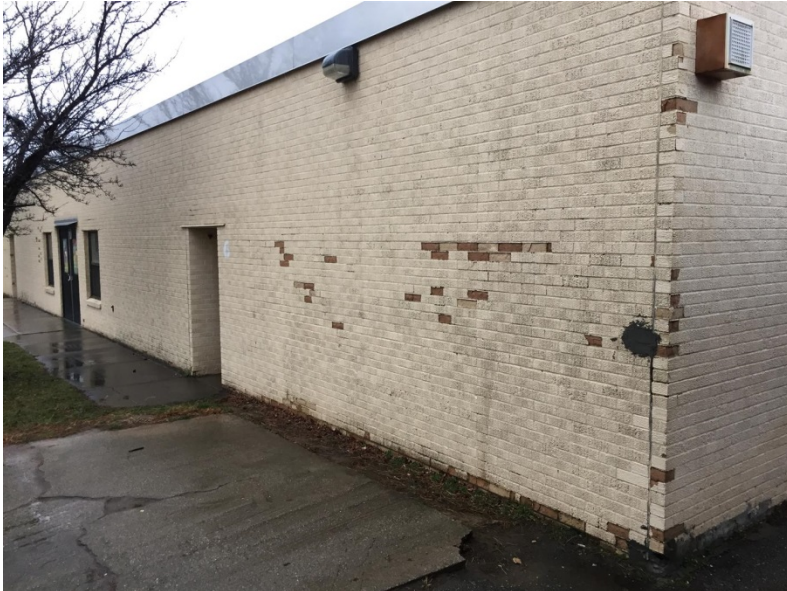
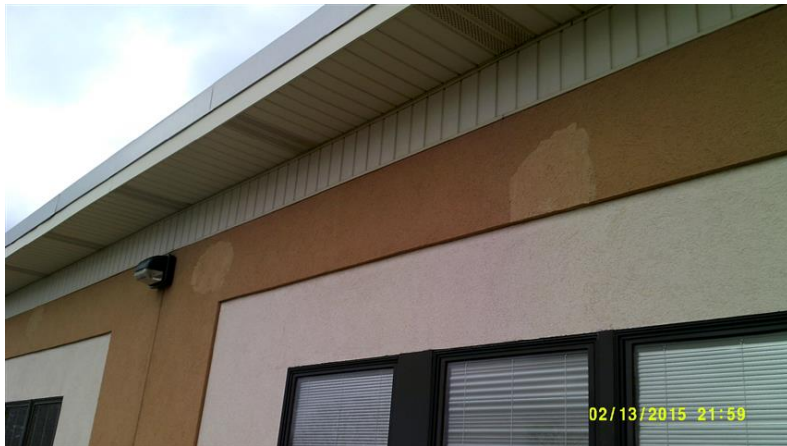
### **Exterior Envelope:** (average rating 4.83)

- Exterior Skin: Brick / EIFS / CMU / Vinyl Soffit & Fascia
- Windows: Clad wood (majority); some aluminum replacement; condition of integral blinds vary
- Doors: Majority hollow metal; susceptible to corrosion
- Roofing: +/- 60% of roofing in need of replacement in 5-7 years\*
- General Observations:
  - Evidence of brick spalling (moisture concerns)
  - EIFS shows evidence of damage / patching / repairs over time; critical to keep up on maintenance to prevent water infiltration over time
  - Windows are in need of replacement (ELPS has been replacing them a few at a time recently)
  - Exterior joint sealants / caulking are in need of attention

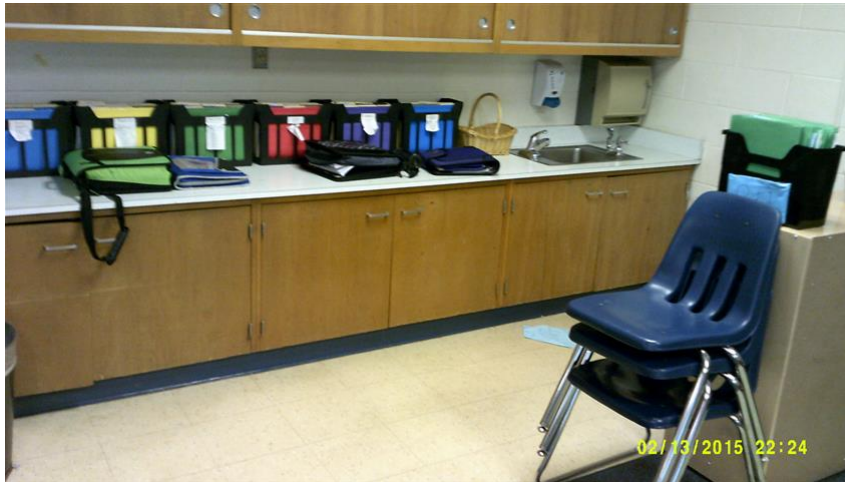
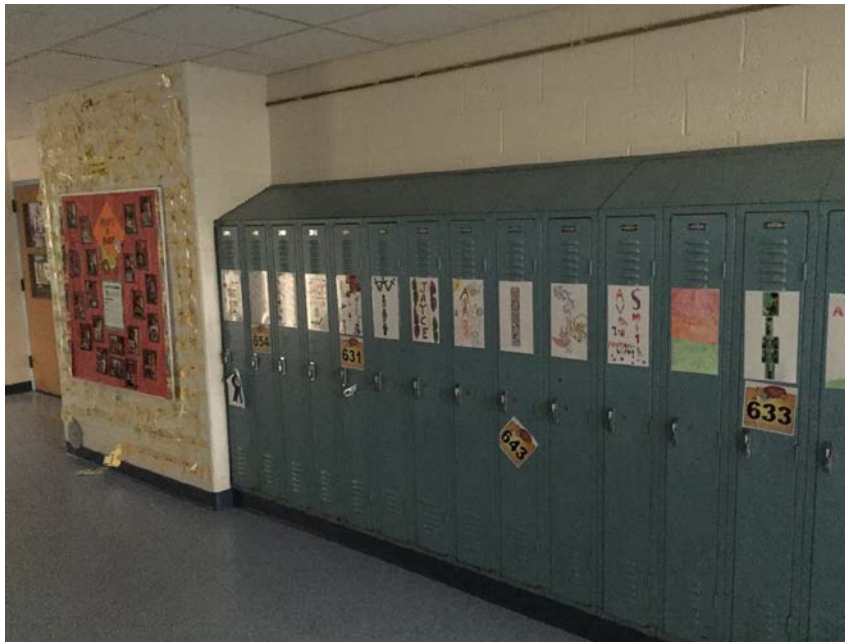
## Interior Architectural Elements:

- Flooring: Majority of flooring “fair” range, exception being corridors and classroom walk-off areas, which have been replaced w/ resilient sheet product
- Painting / Wall Coverings: Majority of walls are painted CMU, “fair” to “good” range
- Casework / Cabinetry: Mix of wood and plastic laminate; majority in the “fair” to “poor” range (water damage, hardware concerns)

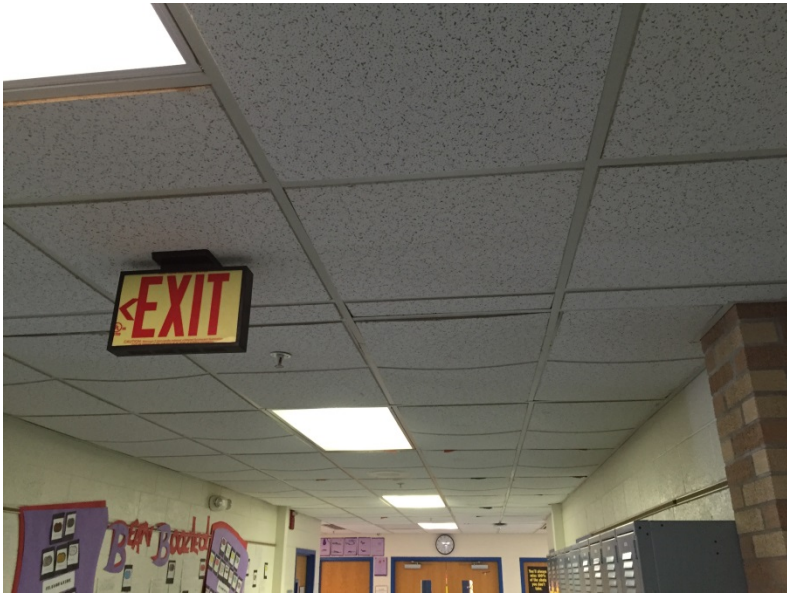
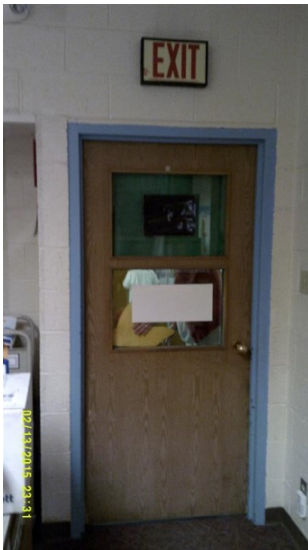
## Interior Architectural Elements (continued):

- Doors / Hardware: 1990's addition – “good,” earlier phases – “poor,” door knob hardware doesn't meet barrier free
- Ceilings: Existing tiles are worn, sagging in certain locations
- Lockers: Sizes vary; rusted bases, bent tops, 9” lockers have limited functionality due to size
- Miscellaneous: n/a

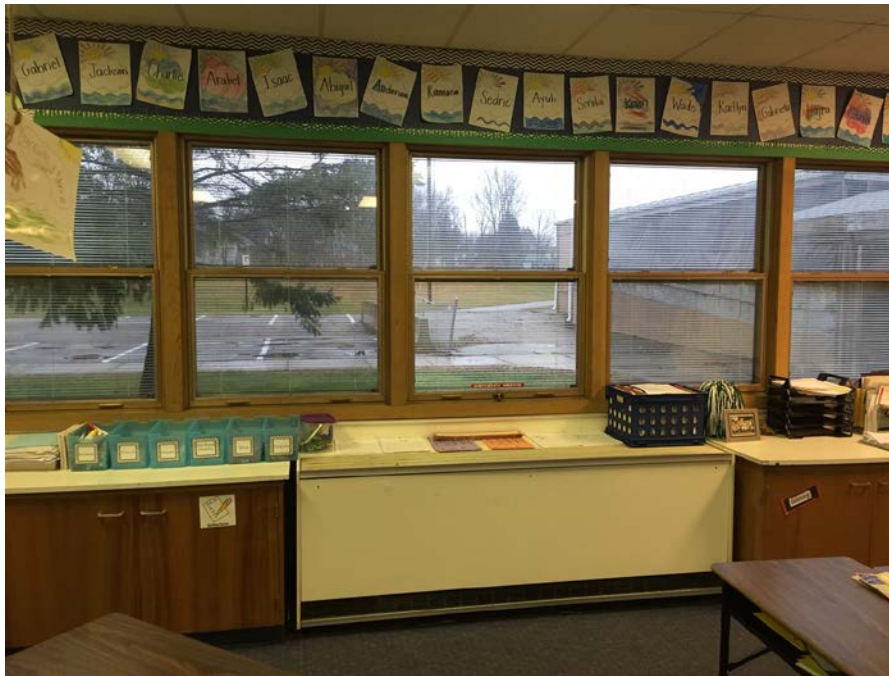
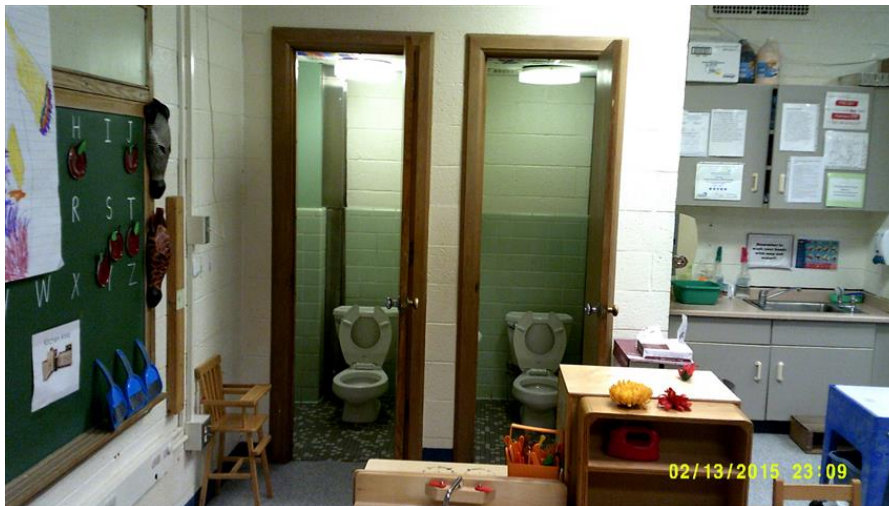
- Steam Boilers ('92); portion of building converted to hot water w/ heat exchanger
- Unit Ventilators (80's and 90's)
  - Some have DX coils for future cooling
- 1980's Addition: gas fired RTU w/ VAV boxes
- AHU (gymnasium) – 1992 addition
- BMS – Some pneumatic controls remain; some previously converted to DDC (Novar)
- Observations / Recommendations:
  - Steam lines (in tunnels) in need of replacement
  - Recommend converting entire building to hot water
  - Recommend replacement of unit ventilators
  - Update all controls to DDC (trend – district standard)

- Galvanized domestic water piping throughout – needs replacement
- Tunnels frequently flood – managed by sump pumps
- Barrier free concerns at many toilet rooms / fixtures
- Building is fully sprinkled

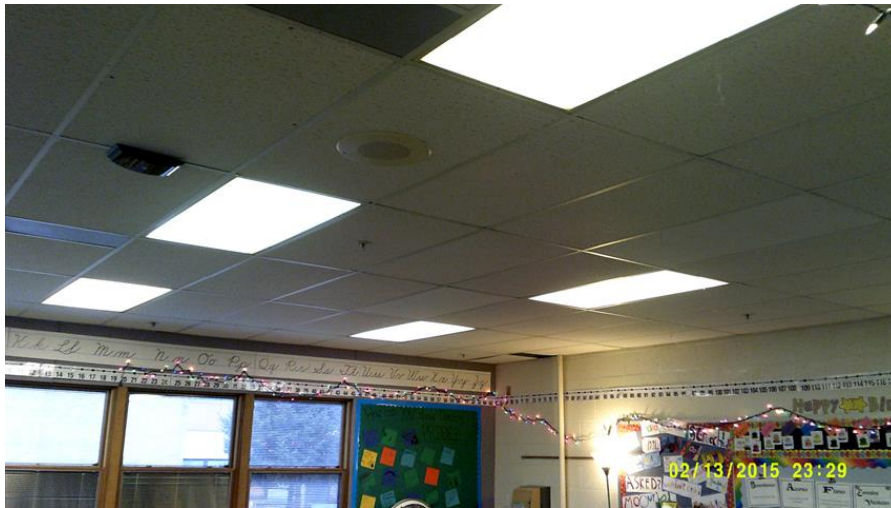
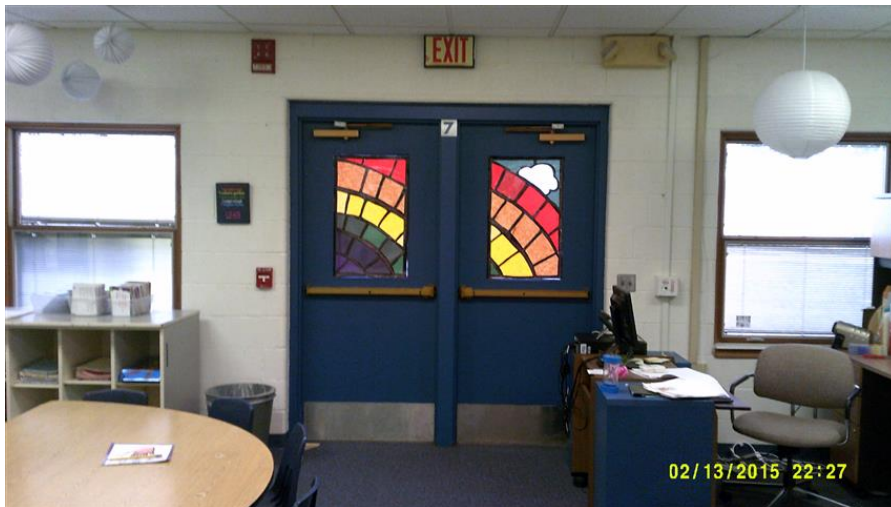
- Original electrical service equipment; service upgrade likely required to support future HVAC upgrades and / or facility expansion

- 2x4 T-12 fluorescent lensed troffers throughout
- Emergency Lighting – “Frogeye” fixtures are unable to be tested and need replacement
- “Glow” exit signs are code compliant, but ideally would be replaced with lit signage
- No occupancy sensors installed; recommend install sensors in accordance with energy code requirements

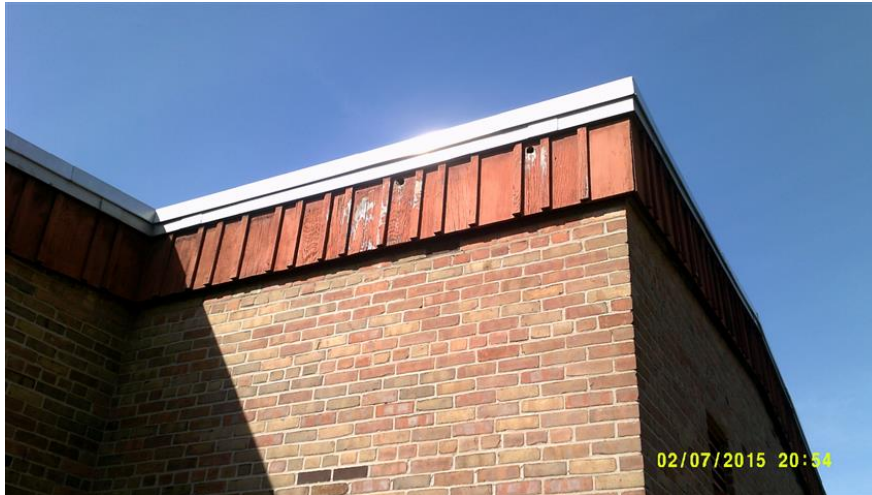
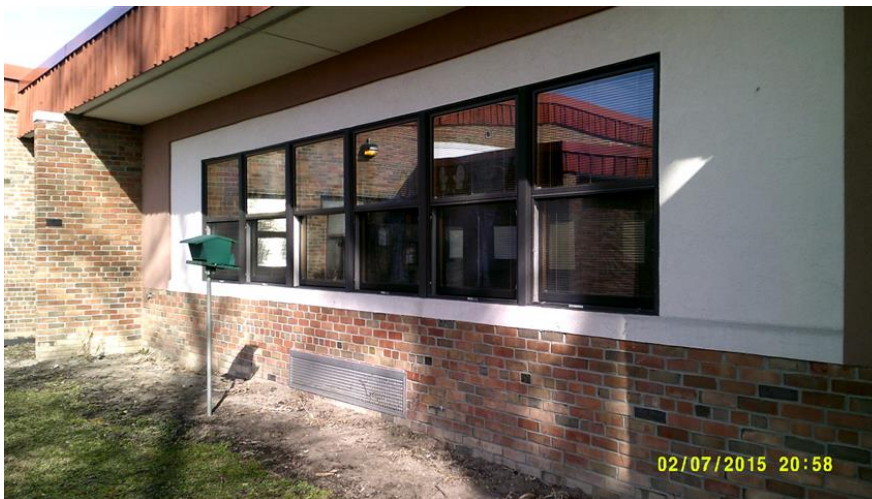
**Exterior Envelope:** (average rating 5.5)

- Exterior Skin: Brick / EIFS / DEFS / Painted Cedar
- Windows: Aluminum Clad Wood
- Exterior Doors: Aluminum & Hollow Metal
- Roofing: +/- 40% of roofing in need of replacement in 5-7 years\*
- General Observations:
  - Evidence of minor brick spalling / cracking; history of major foundation settling at gymnasium
  - DEFS soffits require general maintenance (painting)
  - Windows are in need of replacement
  - Exterior joint sealants / caulking are in need of attention
  - Exterior cedar siding needs general maintenance (painting)

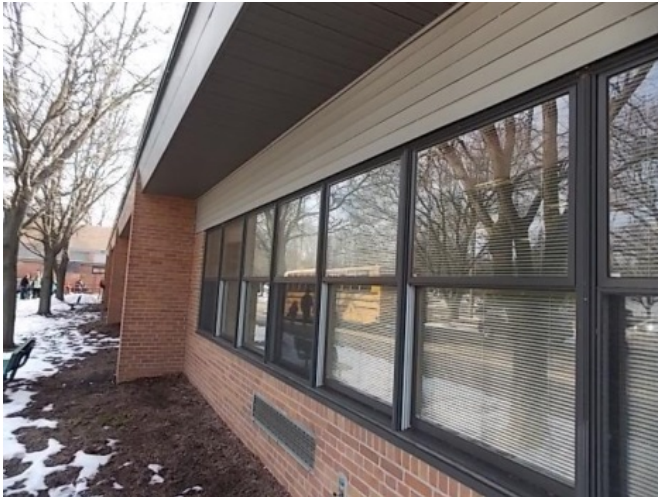
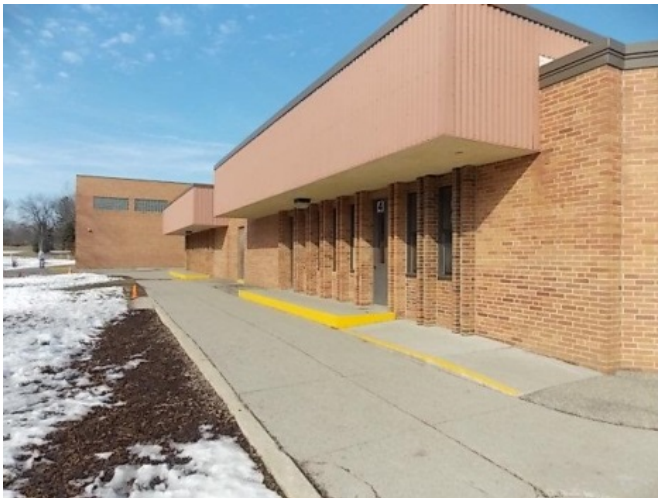
**Exterior Envelope:** (average rating 5.6)

- Exterior Skin: Brick / aluminum soffit / corrugated metal / DEFS / metal siding
- Windows: Aluminum clad wood (25+ years old), glass block
- Exterior Doors: Aluminum & hollow metal
- Roofing: +/- 20% of roofing in need of replacement in 4-7 years\*
- General Observations:
  - Masonry cracks and missing mortar
  - DEFS soffits require general maintenance (painting)
  - Windows are in need of replacement
  - Exterior joint sealants / caulking are in need of attention

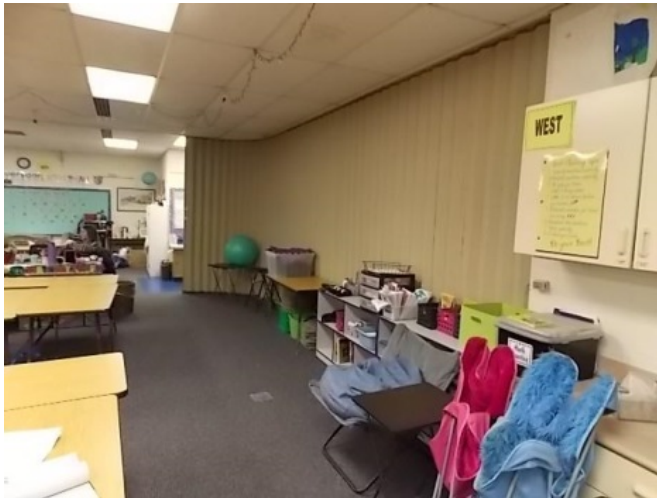
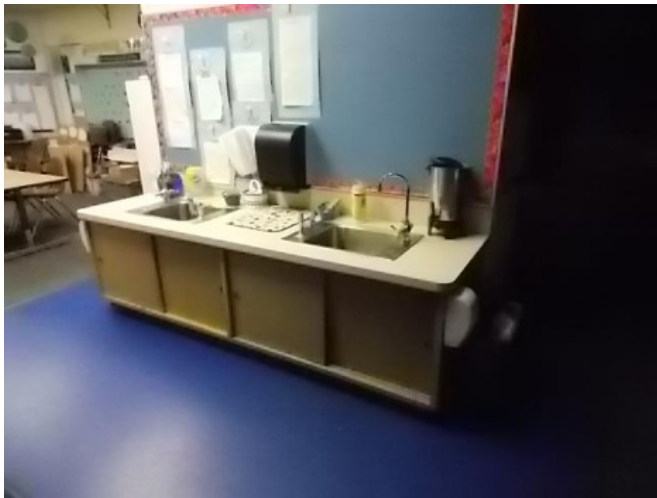
## Interior Architectural Elements (continued):

- Doors / Hardware: 1990's addition – “good”; earlier phases – “poor,” door knob hardware doesn't meet barrier free; many existing wood doors should be replaced
- Ceilings: Existing 2x2 tiles are worn, sagging in certain locations; existing tectum ceiling panels in “fair” to “good” condition
- Lockers: Locker sizes vary throughout; tall relative to grade levels; when double loaded they create tight corridors; locker bases are rusted
- Miscellaneous:
  - Curtains in open concept classrooms are acoustically inadequate
  - Classroom sizes and configurations vary drastically throughout the building

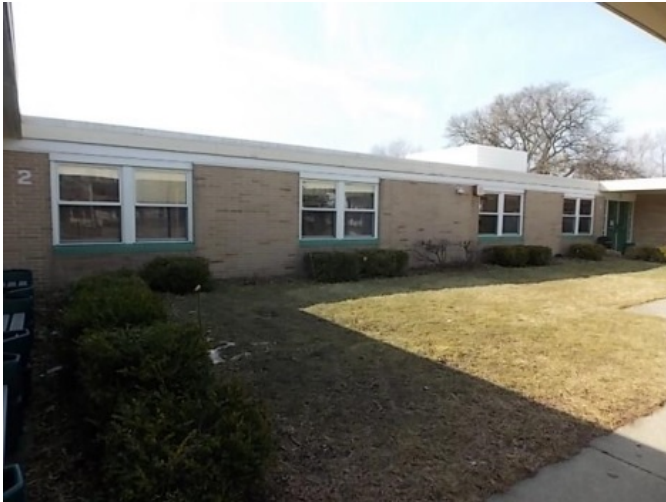
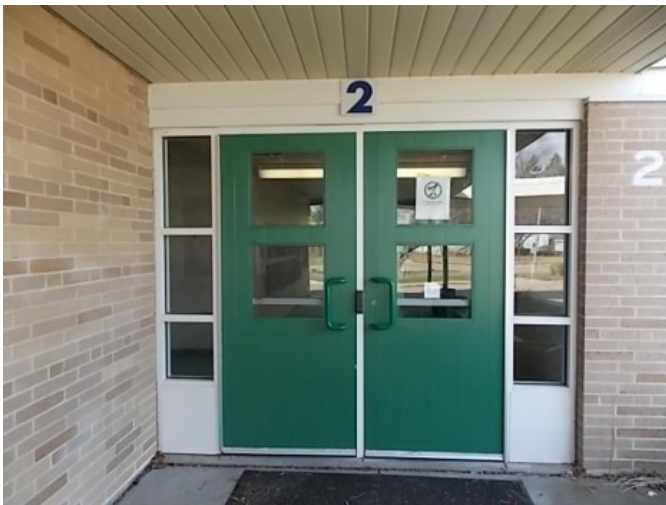
### **Exterior Envelope:** (average rating 5.33)

- Exterior Skin: Brick / aluminum soffit / metal fascia
- Windows: Aluminum clad wood (25+ years old), glass block
- Exterior Doors: Aluminum & hollow metal
- Roofing: +/- 45% of roofing in need of replacement in 2-3 years, +/- 40% of roofing in need of replacement in 5-7 years\*
- General Observations:
  - Masonry cracks and missing mortar
  - Windows are in need of replacement
  - Exterior joint sealants / caulking are in need of attention
  - Recommend replacement of majority of exterior doors / frames

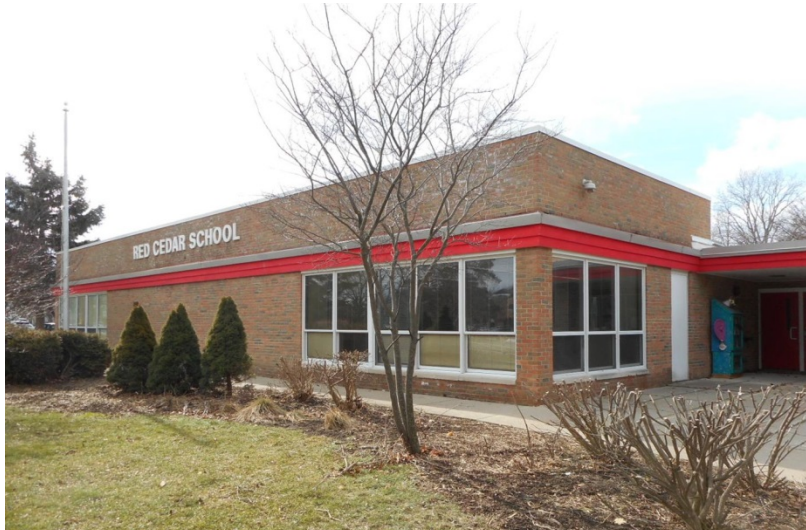
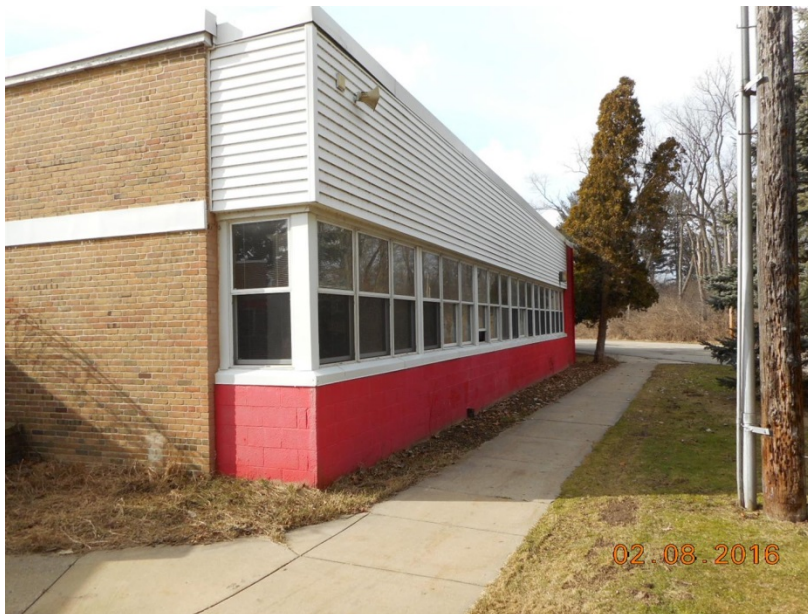
## **Exterior Envelope:** (average rating 5.0)

- Exterior Skin: Brick / painted CMU / vinyl siding / aluminum soffit / painted plywood soffit / metal fascia
- Windows: Aluminum clad wood (25+ years old)
- Exterior Doors: Aluminum & hollow metal
- Roofing: +/- 60% of roofing in need of replacement in 3-7 years
- General Observations:
  - Masonry cracks and missing mortar
  - Windows are in need of replacement
  - Wood soffits should be painted and / or clad w/ metal soffit panels
  - Exterior joint sealants / caulking are in need of attention
  - Recommend replacement of majority of exterior doors / frames

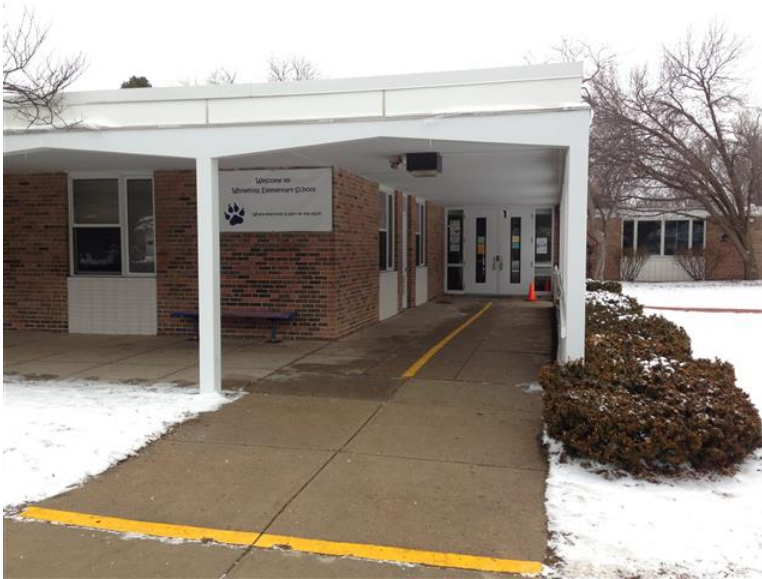
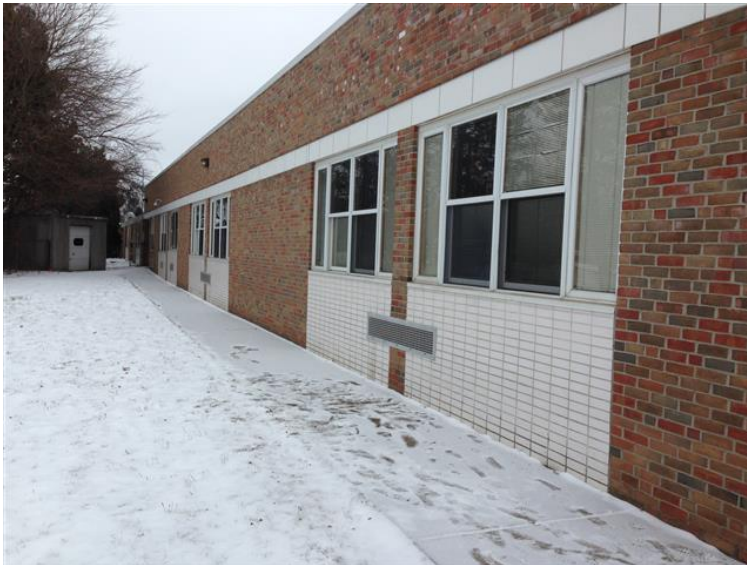
## **Exterior Envelope:** (average rating 4.8)

- Exterior Skin: Brick / DEFS / Painted Metal Soffit
- Windows: Aluminum clad wood (25+ years old)
- Exterior Doors: Aluminum & hollow metal
- Roofing: +/- 65% of roofing in need of replacement in 3-5 years
- General Observations:
  - Masonry cracks and missing mortar; general masonry repair
  - Windows are in need of replacement
  - Exterior joint sealants / caulking are in need of attention
  - Recommend replacement of majority of exterior doors / frames
