## **East Lansing Public Schools - Elementary Facilities Overview**

06.20.16

## Elementary Facilities Overview:

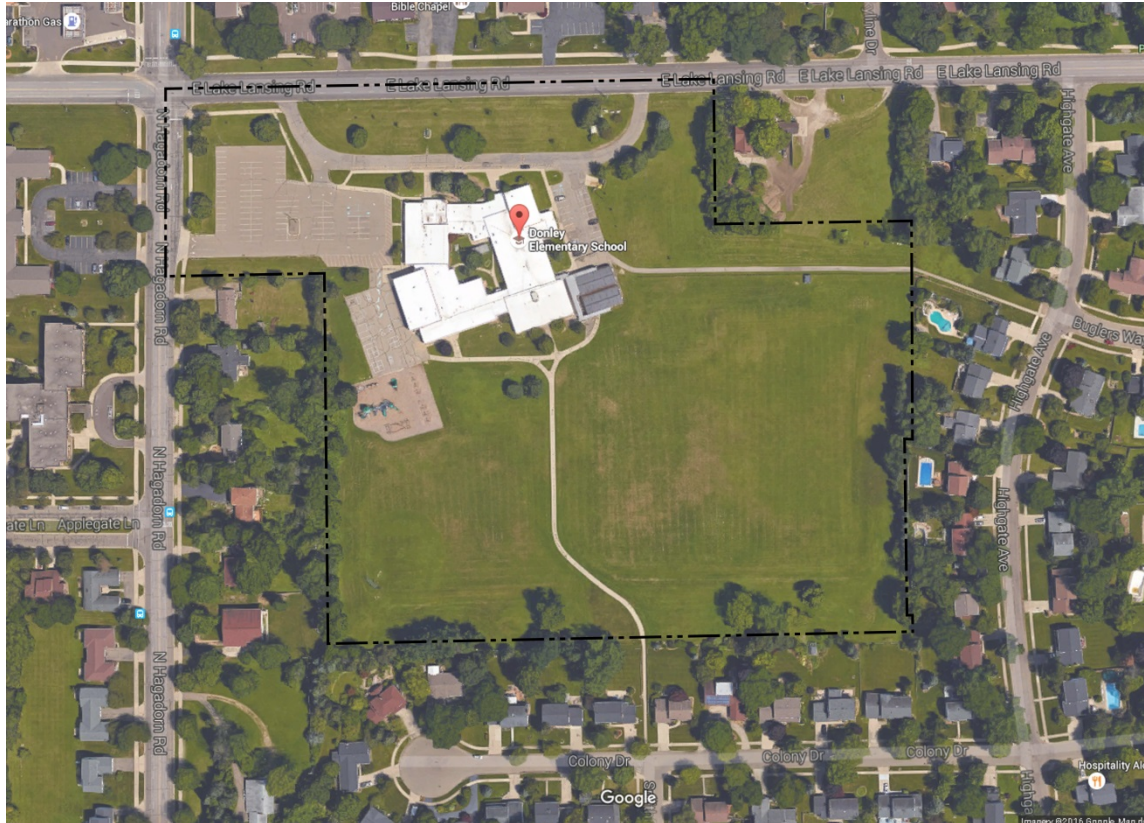
## Site Observations:

- Traffic Flow: Bus / vehicle traffic mixing during afternoon pick-up time, despite attempts to separate traffic.
- Paving: *Assessment to be finalized.*
- Playground: *Assessment to be finalized.*
- Miscellaneous:
  - Site drainage concerns at south end; grade slopes toward building.
  - Site has room for additional development.

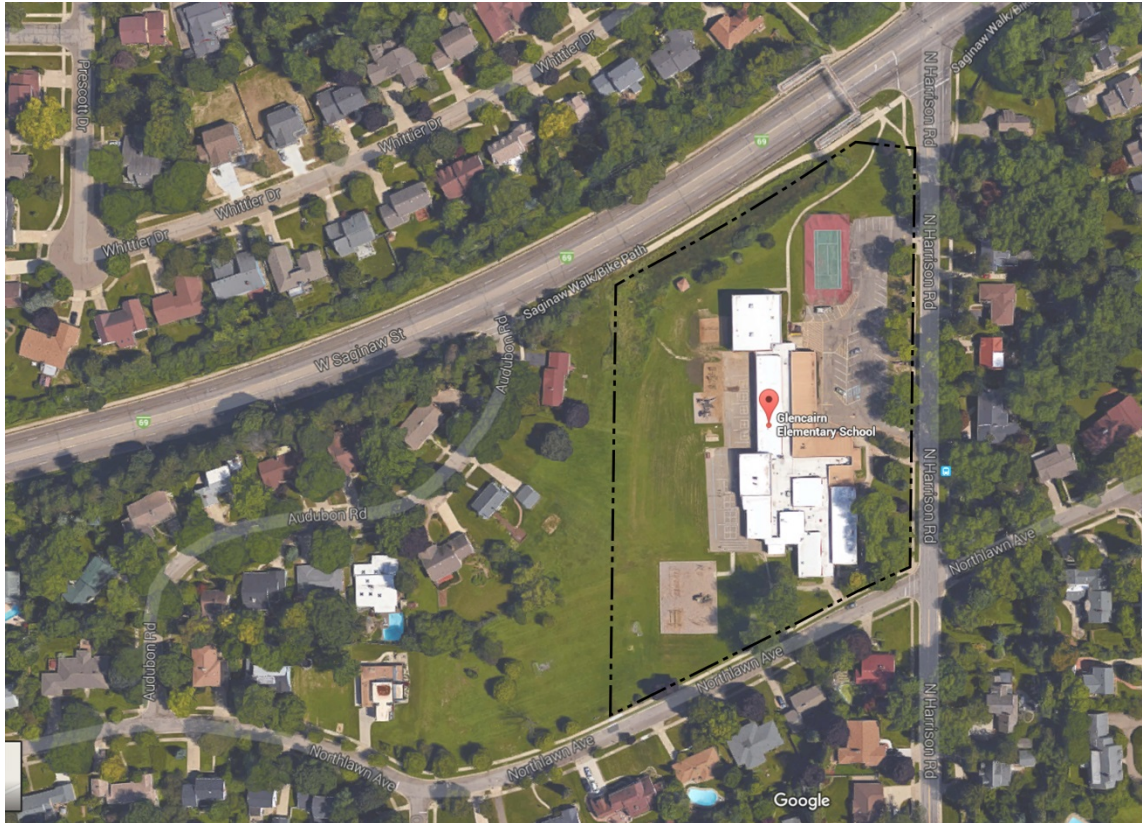
## Site Observations:

- Traffic Flow: Attempt to separate bus and vehicular traffic, but not enough room on site to do this effectively
- Paving: East paving is in need of replacement
- Playground: Upper and lower elementary playgrounds are separate; equipment appears very new
- Miscellaneous:
  - Significant grade changes to the west.
  - Very little room for site improvements to the East / South
  - Very little onsite parking

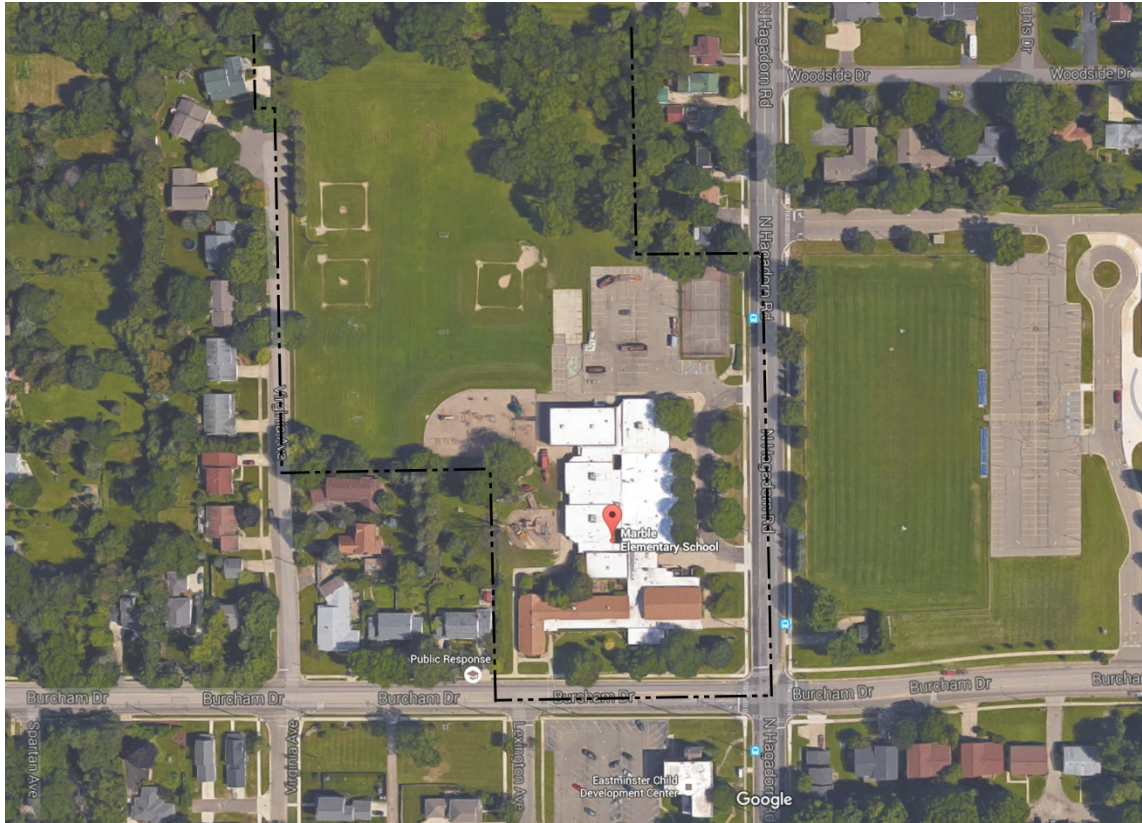
## Site Observations:

- Traffic Flow: Attempt to separate bus and vehicular traffic, but traffic shares common entrance, causing interference
- Location of office is remote relative to parking / drop-off / pick-up
- Paving: North paving is in need of replacement
- Playground: Playground equipment appears to be newer and in good condition; adequate open space for play fields
- Very little room for site improvements to the East / South
- Very little onsite parking

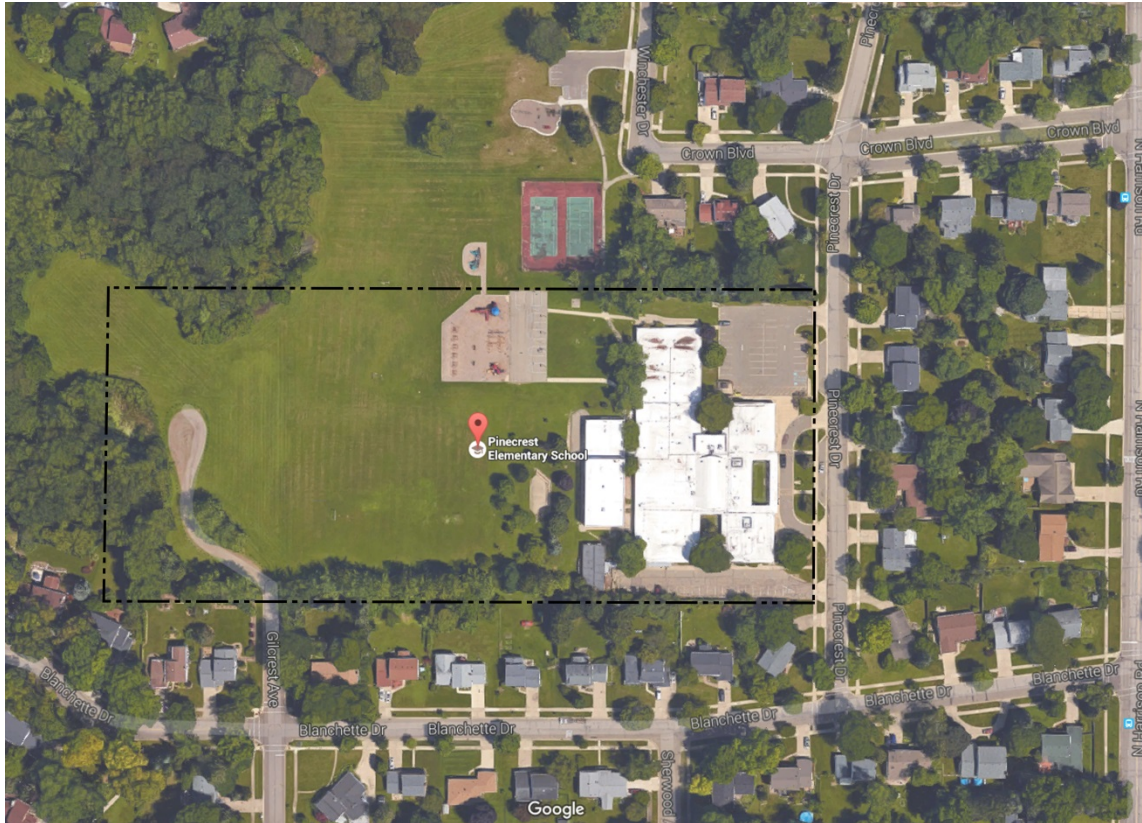
## Site Observations:

- Traffic Flow: Attempt to separate bus and vehicular traffic, but each zone is undersized for its use; Pinecrest Drive becomes one-way during pick-up; disruptive to through traffic
- Paving: South paving is in need of replacement
- Playground: Playground equipment appears to be newer and in good condition; adequate open space for play fields
- Very little room for site improvements to the east / south and north
- Very little onsite parking

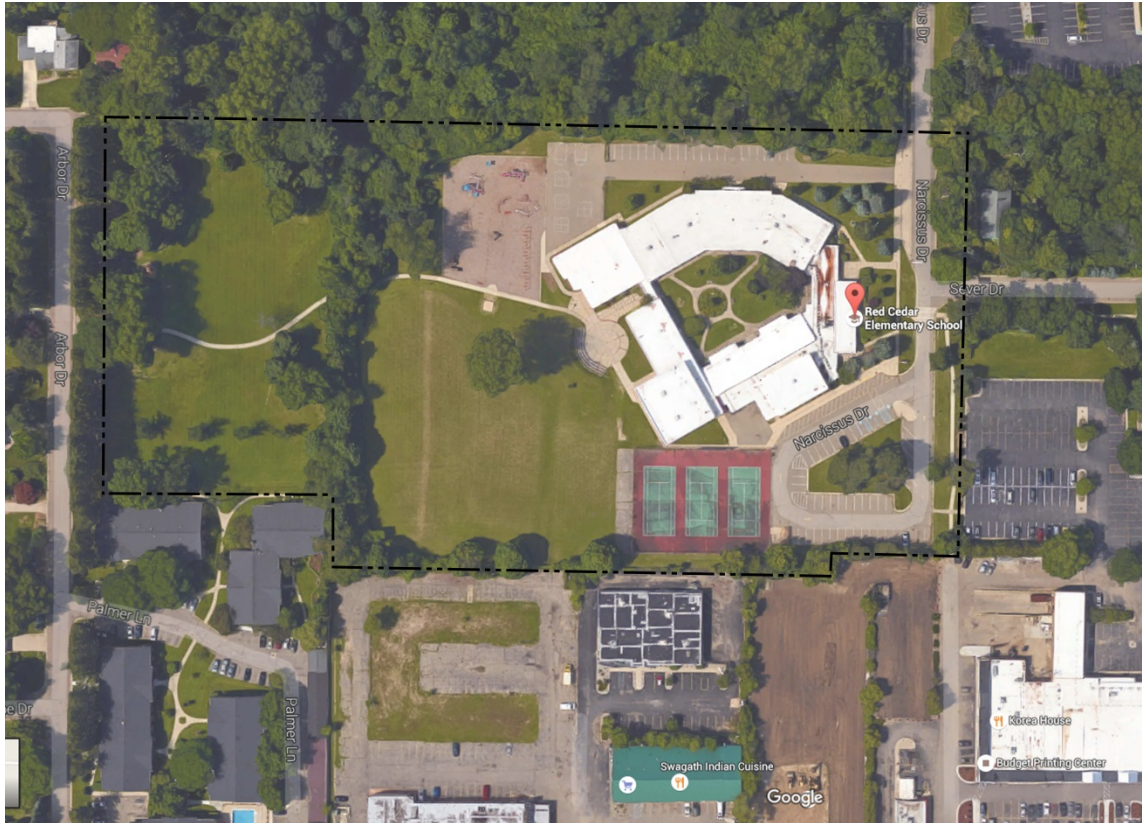
## Site Observations:

- Traffic Flow: Parent drop-off appears adequate, but stacking space is minimized due to integral parking
- Buses drop off on street – not ideal
- Paving: All paving should be evaluated for replacement in near future
- Playground: Playground equipment appears to be newer and in good condition; minimal open space for play fields; exterior courtyard utilized for play space
- Very little room for site improvements to the east and north
- Very little onsite parking

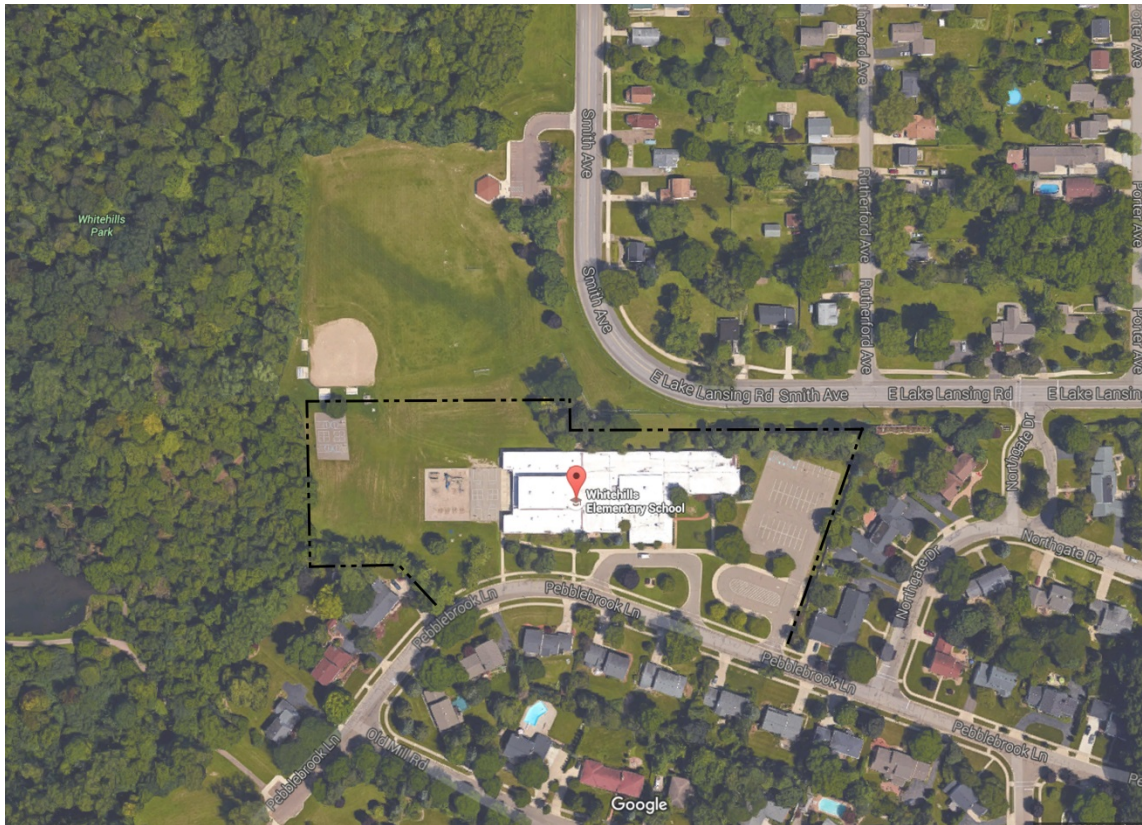
## Site Observations:

- Traffic Flow: Attempt to separate bus and vehicular traffic, but each zone is undersized for its use
- Significant grade change to the west
- Paving: Good condition
- Playground: Playground equipment appears to be newer and in good condition; some open space for play fields
- Very little room for expansion on this site; some space to work with at SE corner
- Very little onsite parking
